# Manhole Inspection Summary

Manhole # S31UU\_035MH

**Location** Address: **334 29TH ST**

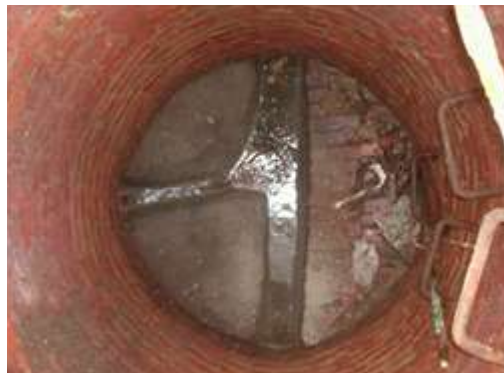
Top View

Corroded steps. Evidence of surcharge - Bench debris. Channel debris.

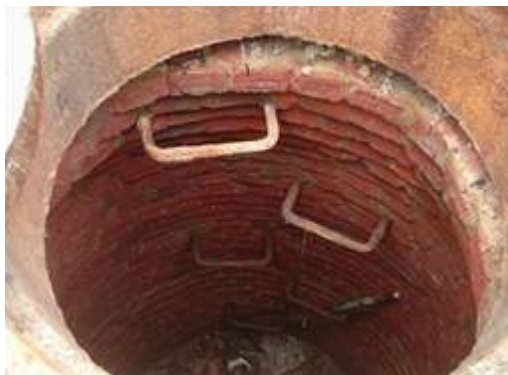
Defect

Frame leaks. Adjustment deterioration and infiltration. Corbel and Barrel infiltration - other side.

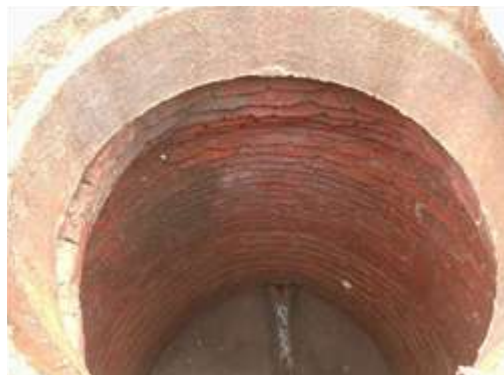
Defect

Frame leaks. Adjustment deterioration and infiltration. Corbel and Barrel infiltration.

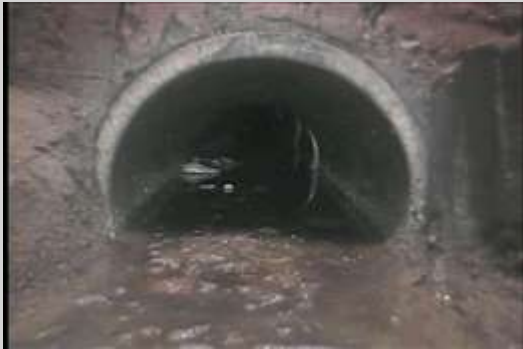
### 8 in. Circular Gravity Sewer Pipe Out @ 12 O'Clock

Deposits: ☐ None ☒ **Mud** ☐ Sludge ☒ **Debris** ☐ Grease

Silt Depth: **1** (in.) Deposits Extent: **Light**

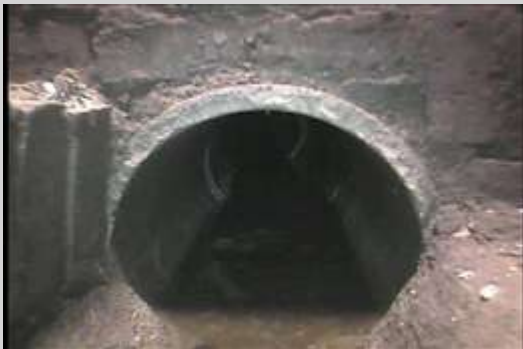
### 8 in. Circular Gravity Sewer Pipe In @ 6 O'Clock

Deposits: ☐ None ☒ **Mud** ☐ Sludge ☒ **Debris** ☐ Grease

Silt Depth: **0.5** (in.) Deposits Extent: **Light**
